State of Illinois
ENVIRONMENTAL PROTECTION AGENCY
MEMORANDUM

DATE: August 23, 2011
TO: Division Files - Bureau of Land
FROM: Chris Cahnovsky – Collinsville Region
SUBJECT: 1198010003 – Madison County
Estate of Chemetco
FOS File

FOUNDRY BUILDING DEMOLITION

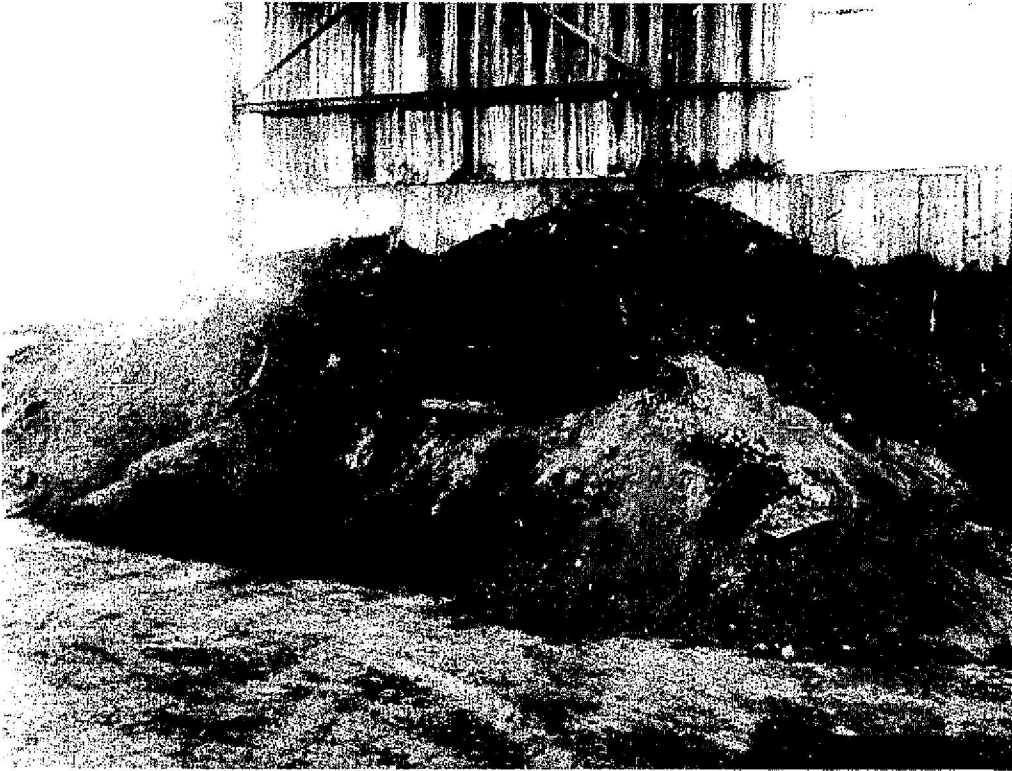
Date: 08/15/2011
Time: 1:15 – 2:30
Direction: Southwest
Photo by: Chris
Cahnovsky
Exposure #: 003
Comments: Material
from beams and
ledges

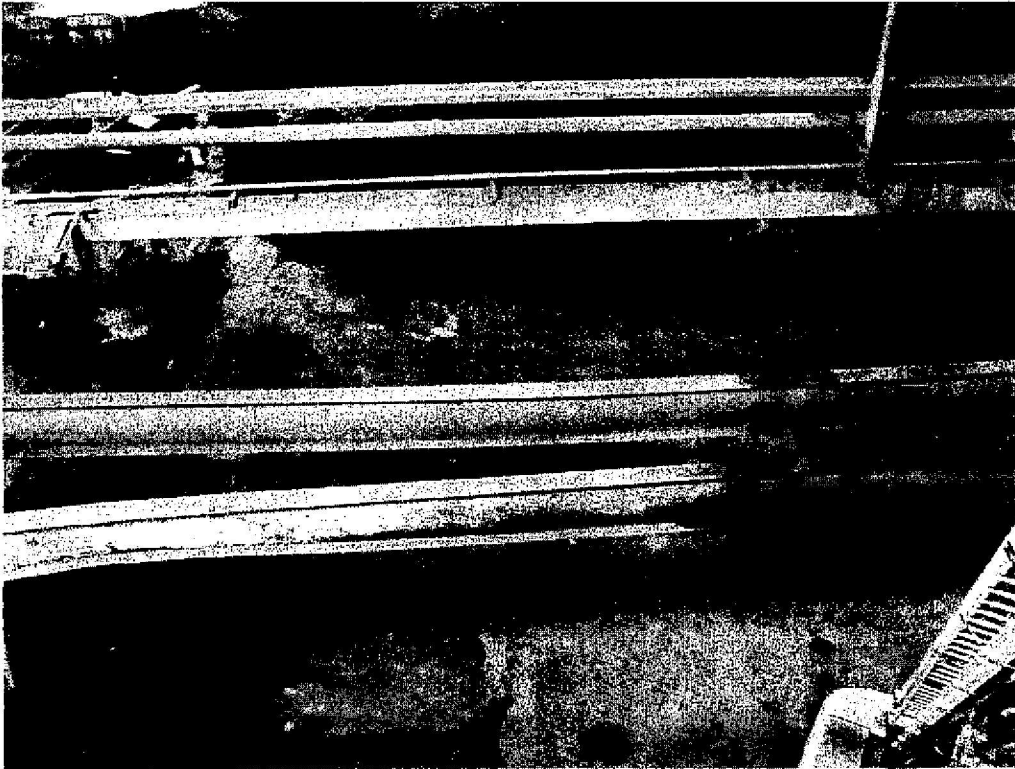
Date: 08/15/2011
Time: 1:15 – 2:30
Direction: West
Photo by: Chris
Cahnovsky
Exposure #: 005
Comments: Beams
that have been
cleaned

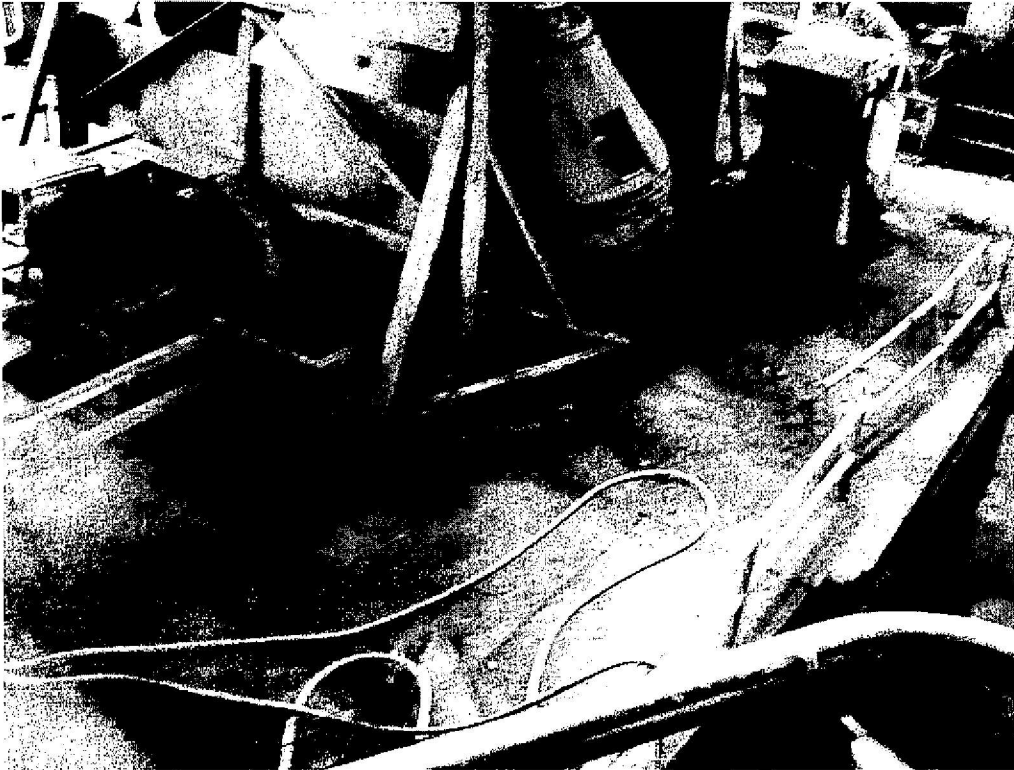
Date: 08/15/2011
Time: 1:15 – 2:30
Direction: Southwest
Photo by: Chris
Cahnovsky
Exposure #: 007
Comments: Second
floor foundry
mezzanine level
after first cleaning

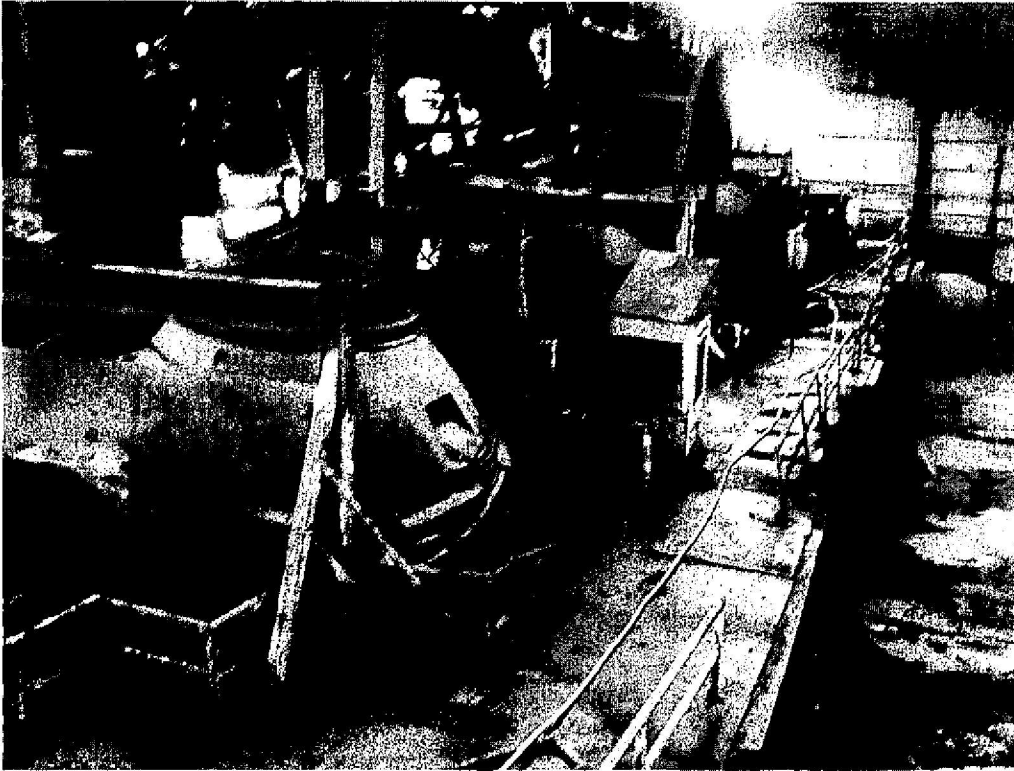
Date: 08/15/2011
Time: 1:15 – 2:30
Direction: South
Photo by: Chris
Cahnovsky
Exposure #: 017
Comments: Second
floor foundry
mezzanine level
after first cleaning
